00Y-TR- 63-20

JUNE 1963

## AIRMUNITIONS TEST REPORT

SERVICE AND SHELF LIFE OF  
EXPLOSIVE SWITCH P/N 1186 FOR  
T3019E5 ARMING PROGRAMMER  
IM99A MISSILE

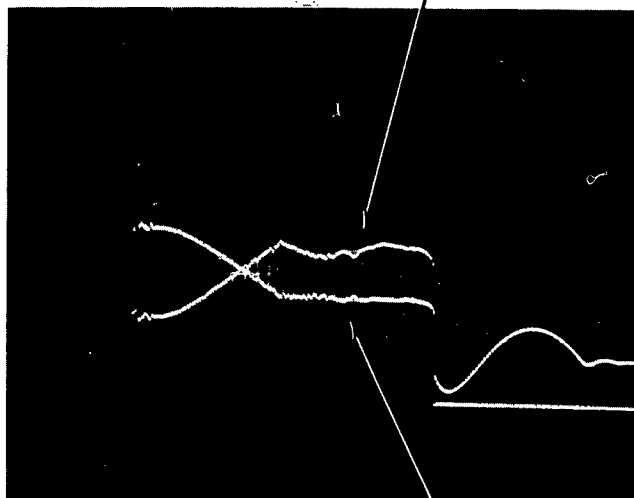
FIGURE 5. Typical Firing Trace - 40°F.

A fire pulse was observed for each switch indicating that the bridge wire had broken. Most fire pulses were recorded by camera. A few pulses were not recorded due to equipment failure. All traces obtained were similar in appearance (Figure 5). Table 1 contains a tabulated record of the firing voltage, firing current, ignition delay and energy input level for each switch.

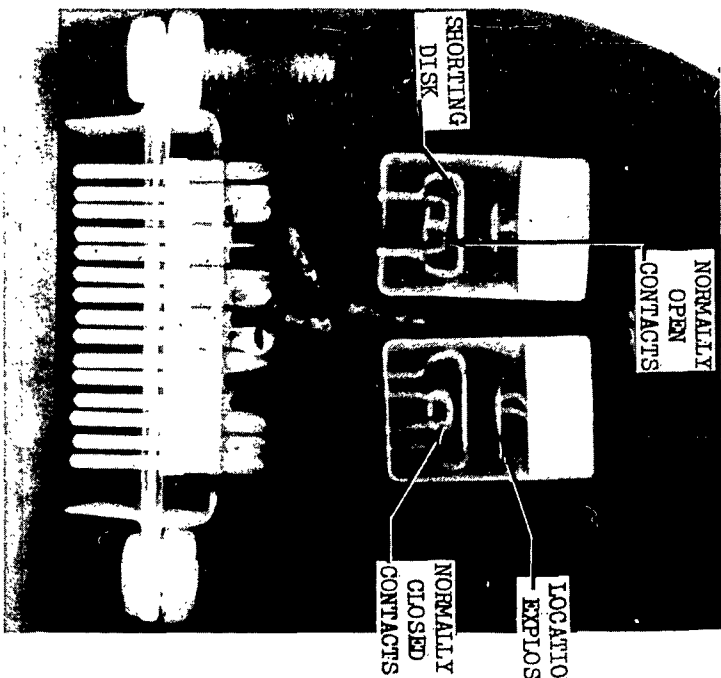
FIGURE 6A. Radiograph of Unfired Switch Module

Radiographic inspection, however revealed that one switch in each of two modules had not functioned. Figures 6A and 6B are radiographs showing the internal details of the switches. One switch was manufactured in January 1960 and one in March 1960.

Apparently the bridge wire had burned open but the explosive had not functioned. In order to determine the cause of the defects, the two faulty switches were carefully dissected by filing away switch material and inspecting the internal structure as the filing proceeded.

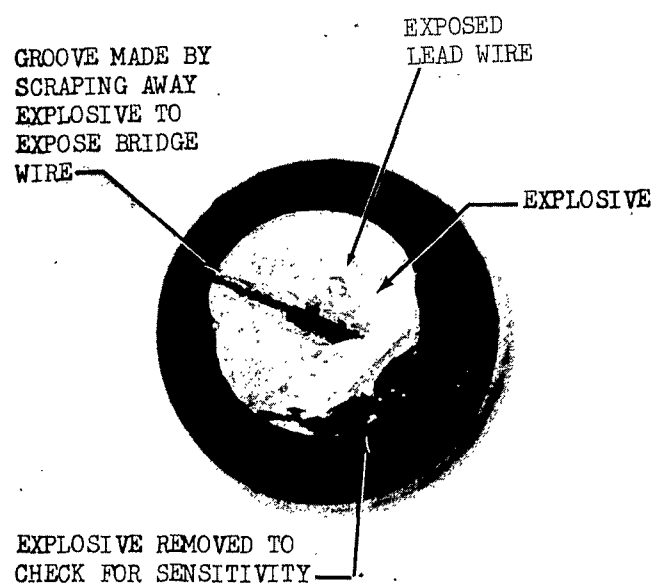
FIGURE 7. Explosive Film Intact After Switch Received Fire Pulse.

The second switch was filed from the top. The potted end of the lead wires with a thin film of explosive was obtained intact (Figure 7). The explosive was scraped away between the lead wire ends revealing that the bridge wire between the lead wires was missing. A tiny portion of the explosive was removed and checked for ignitability by contact with the flame from a match. The explosive detonated with an audible report indicating that it was still sensitive to heat.

As the one sample was filed down from the top, the lead wires were visible. One lead wire was observed to have been inserted in a folded (accordian) like position. The cross section of this wire at various depths from the top of the switch toward the bridge, was not round but rectangular as would be obtained from filing the side of the wire. This folding caused the two lead wires to almost touch at several points. It is conceivable that lead wires inserted in this manner could touch each other, effectively shorting out the bridge. It is not likely that the switches malfunctioned in this way, since the resistance of the bridge circuit was normal for the two switches (5.06 ohm and 7.62 ohm). Also, the bridge wire was not found under the explosive.

1. The explosive immediately around the bridge wire was melted away from the bridge or desensitized from the application of stray voltages or test voltages less than that required for detonation.
2. The bridge wire and explosive were not in intimate contact at the time of manufacture.
